EARTHQUAKE FAILURES ON BUILDINGS AND THE ROLE OF ARCHITECT ON BUILDING SAFETY

Noor Choliz Idham

Architecture Department, Universitas Islam Indonesia
Email: noor.idham@uii.ac.id

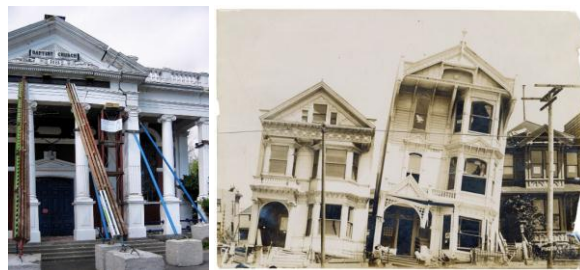
Fig. 1. Structures with heavy materials will always vulnerable to earthquakes New Zealand 2011 and the surviving wooden structure did not collapse instantly in the event of the 1906 San Francisco earthquake (photo: Martin Luff and US National Archives).

The massive building of adobe and reinforced concrete houses will trigger greater inertia during an earthquake because the inertial amplitude will directly proportional to the mass of the structure (Figure.1). The secure building then identic with a light-weight structure such as timber or metal construction. Wooden structure such as *Joglo* is better to deal the quake rather than heavier structure (Maer, 2009; Prihatmaji, 2007). Brick wall houses and RC construction, which is massive, is less suggested for secure building from earthquakes. Masonry building are accounted for most of the building failure up to 70% (Coburn et al., 1992).

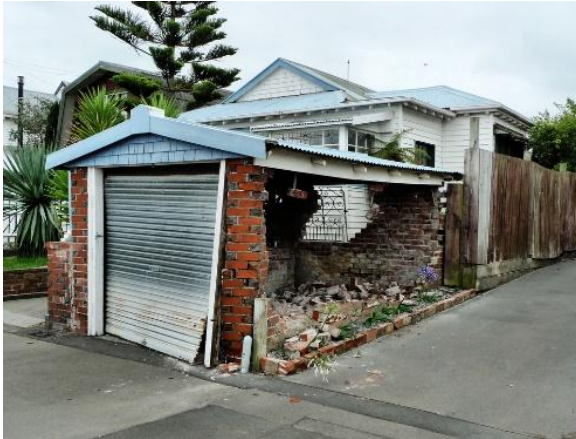
Fig. 2. Low buildings damaged resonated with the high frequencies (photo: Martin Luff)

structural system (Coburn et al., 1992). Short buildings with rigid building materials are particularly vulnerable to short vibration periods (Figure.2). Relatively tall building with flexible structure should be utilized to avoid short-vibration effect since the frequency of those building is less and the swing of the building caused by the small amplitude of the wave. If small or rigid building should be used, the reinforcement should be extra. Again, RC structure in a non-multi-story building is less suggested.

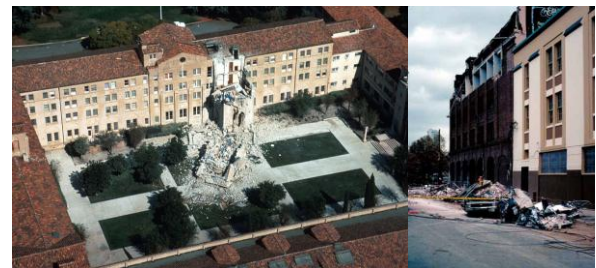
Fig. 3. The adjacent buildings will destroy the weaker one (photo: Wilshire and Meyer USGS)

The hammering or punch effect may happen for many times in correlation with the intensity of the earthquake. The collision between the two buildings will damage both structures, especially the relatively weaker ones. The collision generally occurs in crowded urban buildings or improper building configurations (Figure.3). Building arrangement by keeping enough space in between to expect the sway under quake is urgent to keep every building react freely without affecting each other.

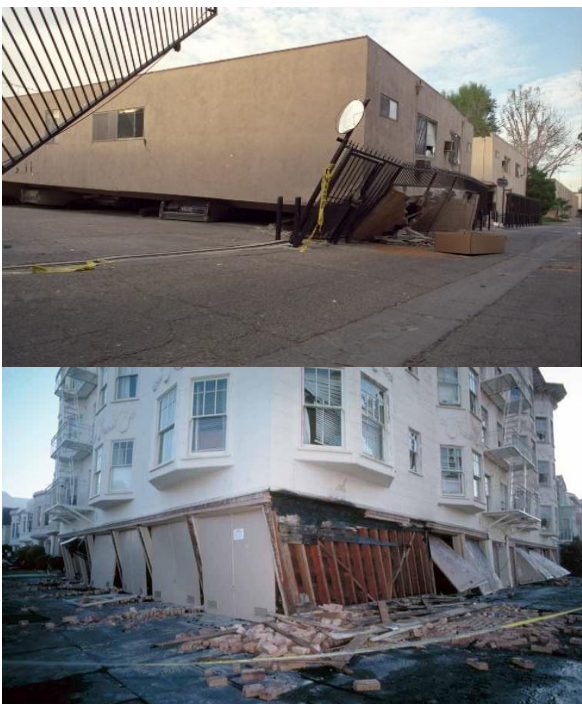
Fig. 5. The impact of the earthquake due to the soft story effect on the building ground floor (photo: Gedstrom and Nakata USGS)

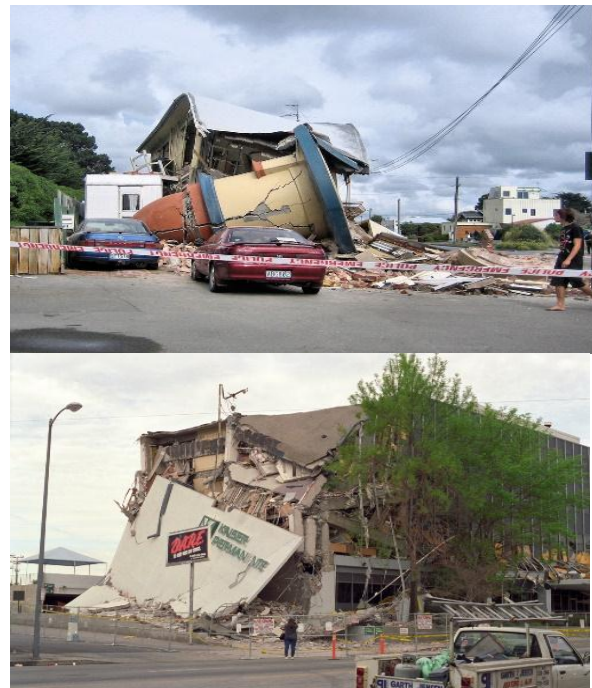
Fig. 6. The failure of heavy elements on the upper floors such as tower roof (left) and wall element (right) in Christchurch 2011 earthquake (photo: Martin Luff)

caused by different levels of the floors in high rise buildings (Figure.6). Architects are suspected of causing the failures since most of them tend to like as 'different' or as 'spectacular.' Plans should be arranged typically in every floor, and the columns must support in line accordingly. If accentuation is needed, a particular treatment should be done to support the load concentration on the spots.

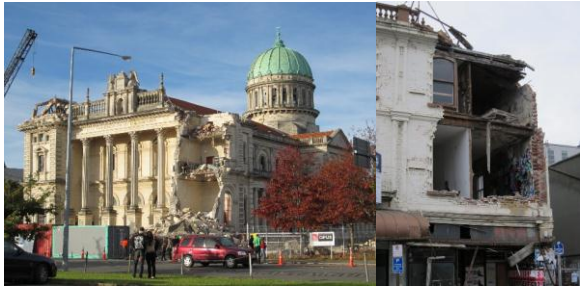
Fig. 7. Damage in the outer elements are generally occurs in the corner of the building (photo: Martin Luff)

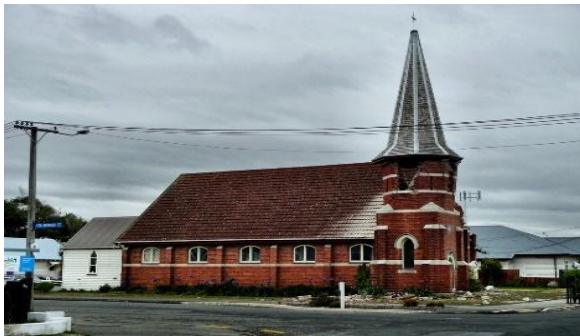
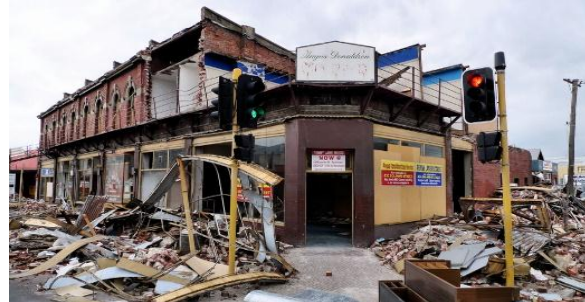
Fig. 8. The asymmetric plan makes the torsional effect on the building (photo: Martin Luff)

Horizontal deviations can be found in an asymmetric building plan because of inequality load between the center of the mass and its outer parts which causing the twisting vibration during the earthquake. More severe damage is expected to occur in building elements on that floor plan and parts of buildings that have a long distance from the center of the mass (Figure.7,8). Compacted plan and mass are needed to avoid building parts overture under the vibration (Giuliani, 2000; Murty et al., 2012). If complicated masses are wanted, the mass segregation should be taken by the structural separation or known as dilatation.

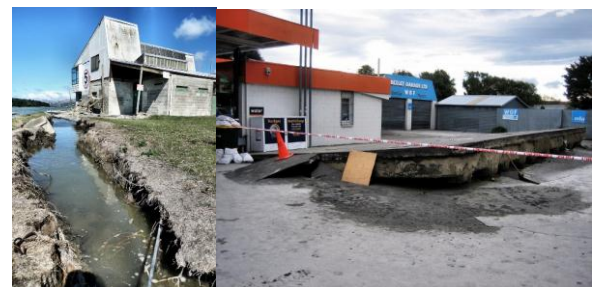
Fig. 10. The foundation failures due to the ground (left) and the liquefaction effect (right) (photo: Martin Luff)

Foundation failure causes significant damage to the building even if the main building itself is not dented. The foundations can experience failure generally due to landslides, liquefaction, crushed valleys, soil compaction, and differential forces (Figure.10). Choosing the safe site is imperative to make sure the building still stand from the soil defects. Otherwise, very sturdy foundations must be applied in the buildings.

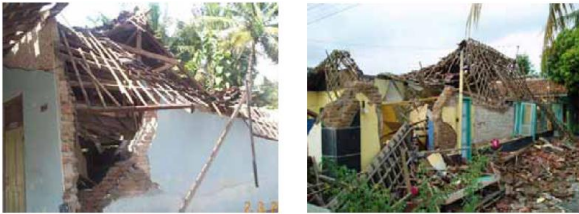
Fig. 11. The broken brick walls (photo: Boen)

area was fragile and built without consideration of the earthquake. According to Boen (Boen, 2006), collapsed houses from the Java earthquake in 2006 was commonly built with brick walls either with or without a reinforced concrete frame. Most of the deaths and injuries were caused by the collapse of the brick building without reinforcement (EERI, 2006). Weak brick-walls are a major factor causing the collapse of the building. In the case of newer homes with reinforced concrete, improper structural connection are the most prominent aspects of structural failure. The most prominent causes of damage to buildings are (Amr S Elnashai et al., 2007): (a) Failure on wall angle and corner of door and window opening, (b) Roof system that shifts from the supporting wall, (c) The occurrence of broken shear or cracked masonry walls, (d) Failure in the connection area between roof, wall and foundation.

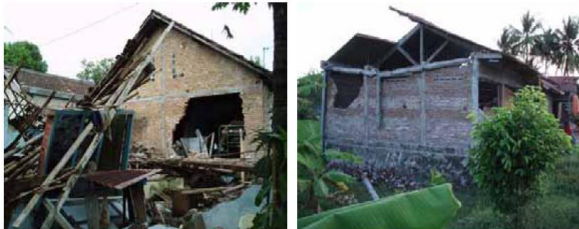
Fig. 12. The broken concrete frames (photo: Boen)
